Bulletin: 2006-004 USA

Subject: RXV/SXV 450/550-- Oil overflowing from airbox/gearbox becoming overfilled

Date: October 2, 2006

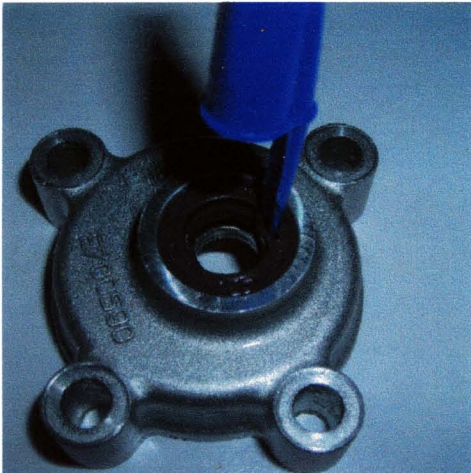
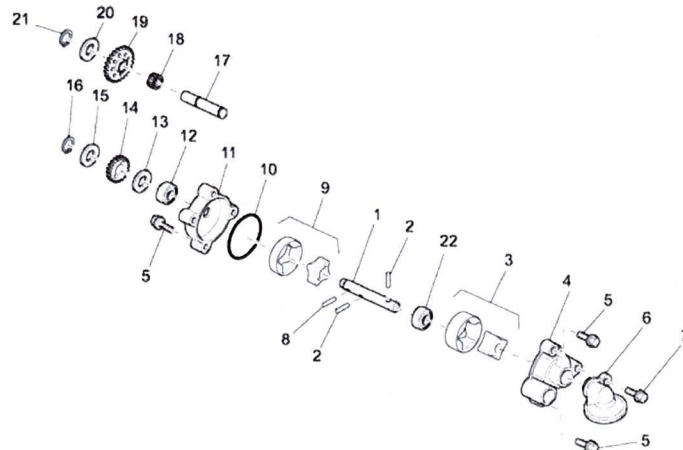
In specific cases investigated by Piaggio USA, the oil seal fitted to the external housing of the oil pump has shown to be defective/improperly installed. If the oil pump seal fails, engine oil will leak into the gearbox cavity, causing the gearbox to be overfilled. This oil mixture then overflows through the gearbox vent hose and into the air box. Due to the sophisticated dry-sump oiling system, it is imperative that the engine oil reservoir and gearbox have been correctly filled. A thorough understanding of the fluid capacity and level checking procedure is essential. This knowledge will prevent undue time and effort searching for an oil system problem, which is non-existent. When it is certain the engine and gearbox oil levels are correct and excessive oil overflows from the air box, proceed as follows:

Oil pump seal #12 (Most importantly)

- 1) [Remove right side clutch cover](#)
- 2) [Remove oil pump gear](#)
- 3) [Inspect oil pump cover seal](#)- Replace if necessary. *A few examples of the SXV 550 have had faulty oil pump seals. As a precautionary measure, examine other seals noted below.*
- 4) [Reinstall Clutch cover](#)
- 5) [Adjust engine oil and gearbox oil levels to specification](#)
- 6) [Test Unit](#)
